PHIPPS GARDEN CENTER AT MELLON PARK

THE PHIPPS GARDEN CENTER AT MELLON PARK

Proposed building and landscape improvements

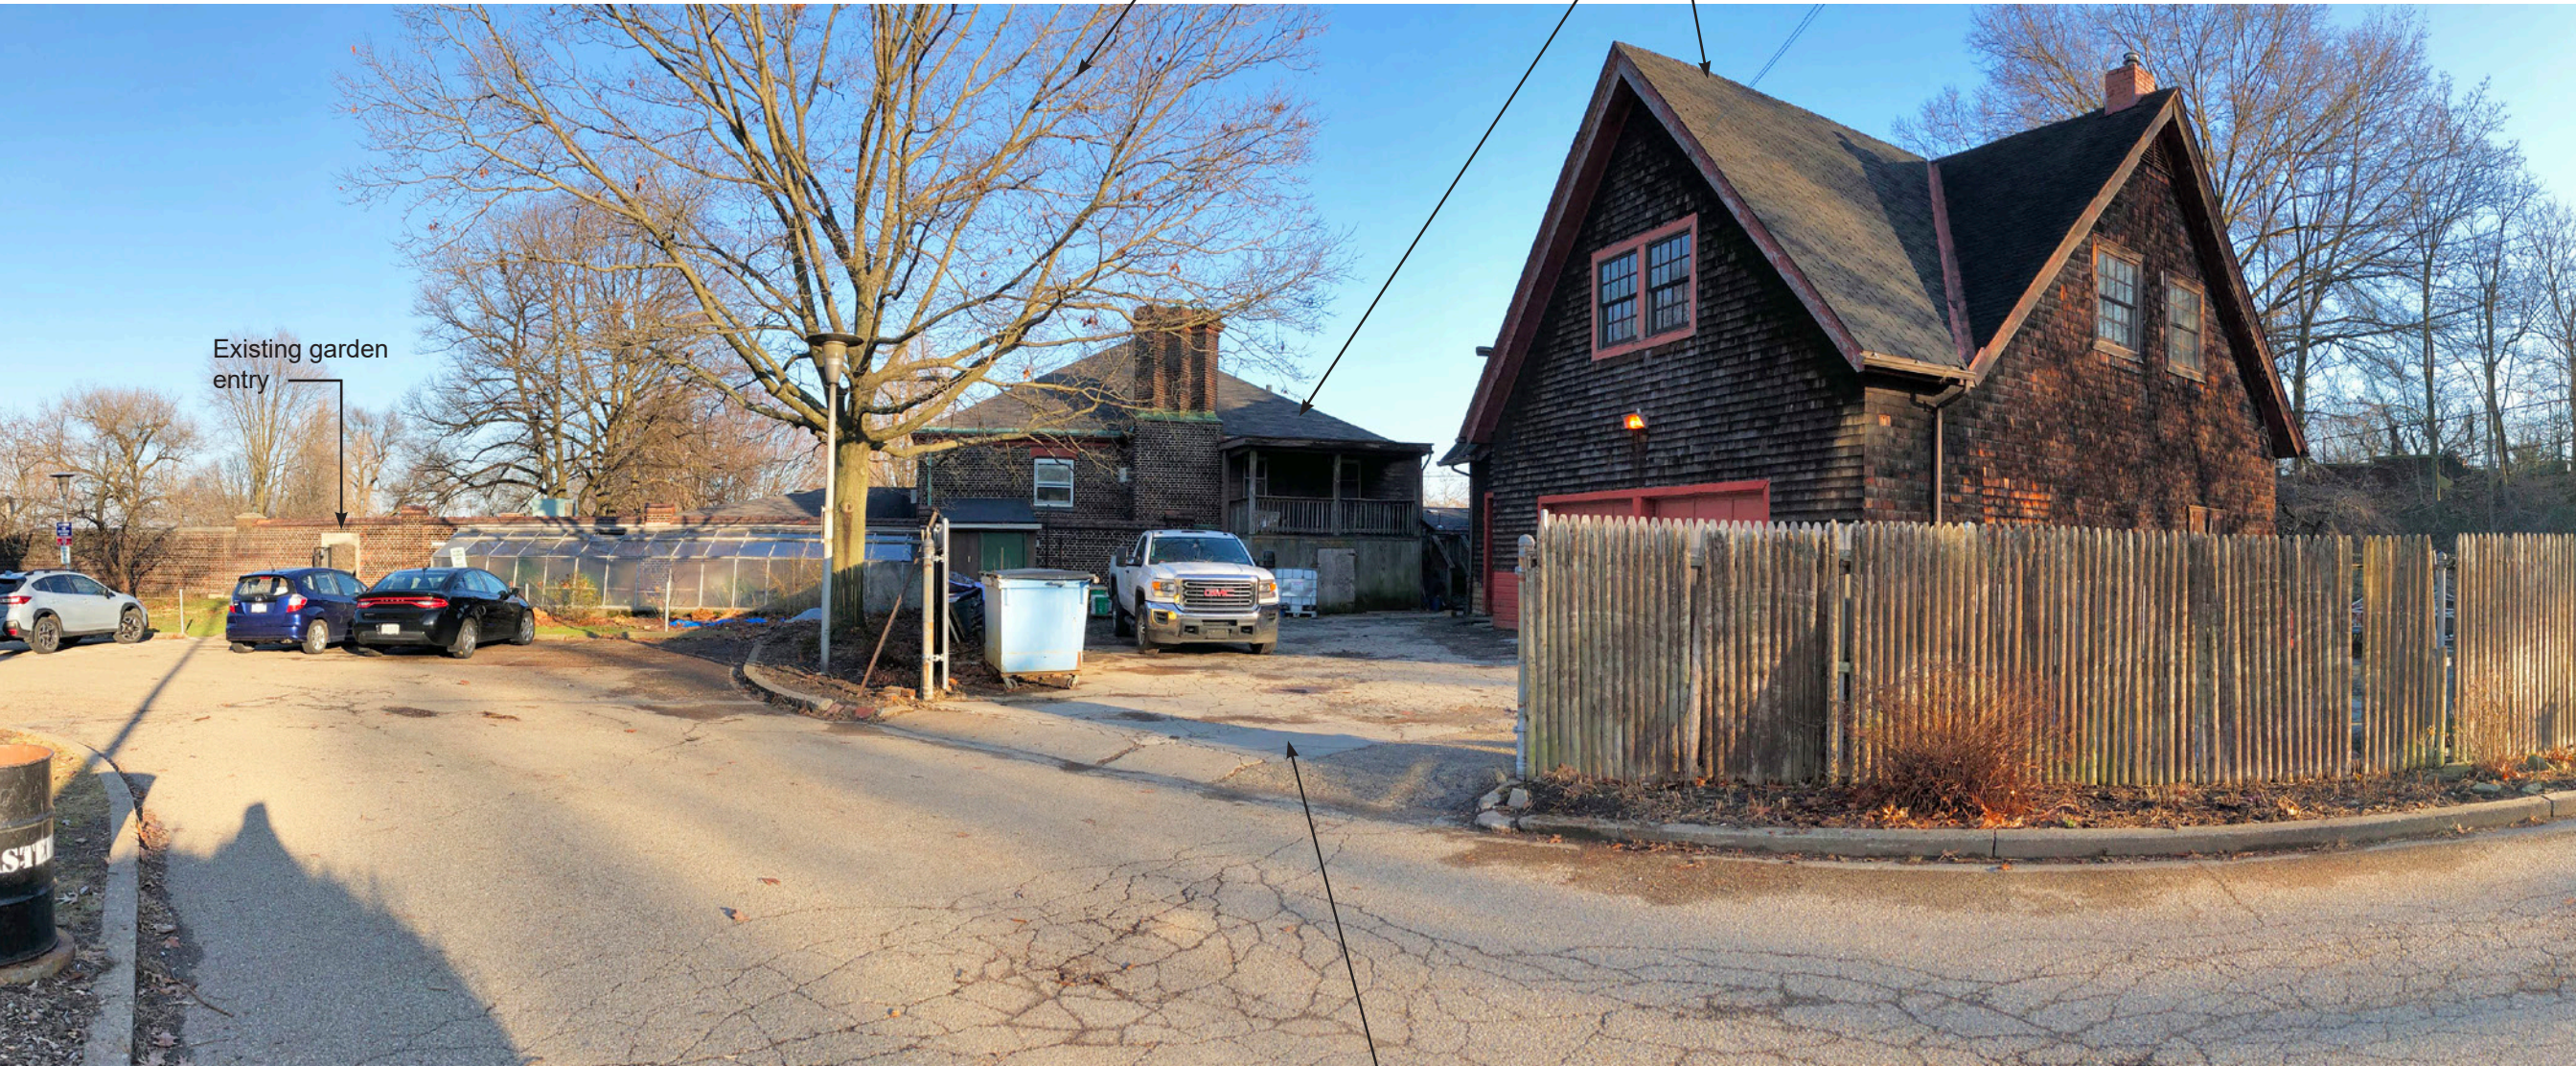
EXISTING SERVICE YARD

Existing garden
entry

Mature tree canopy

Existing historical
garages in deteriorating
condition

Service yard up front

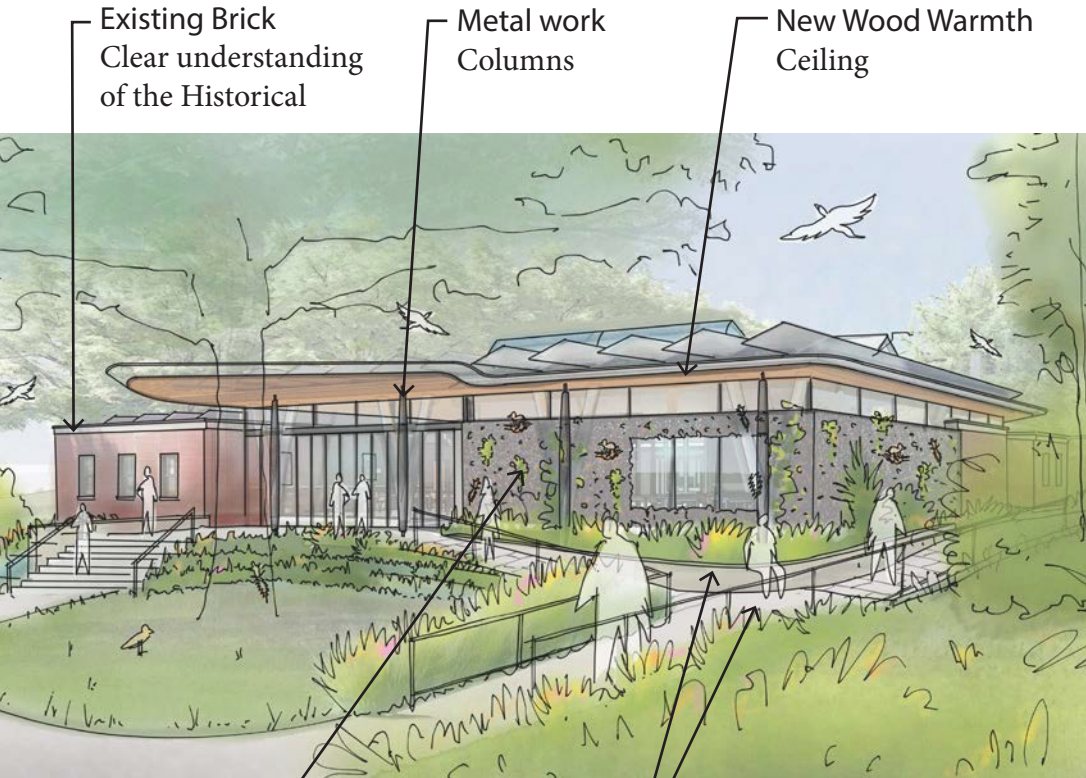
PROPOSED

Terracotta details
New facade material

Stone Details
Site walls and paths
